MEMORANDUM

Date: August 8, 2023

RE: Preliminary Conditions Assessment - Highway 47 Bank Restoration Project

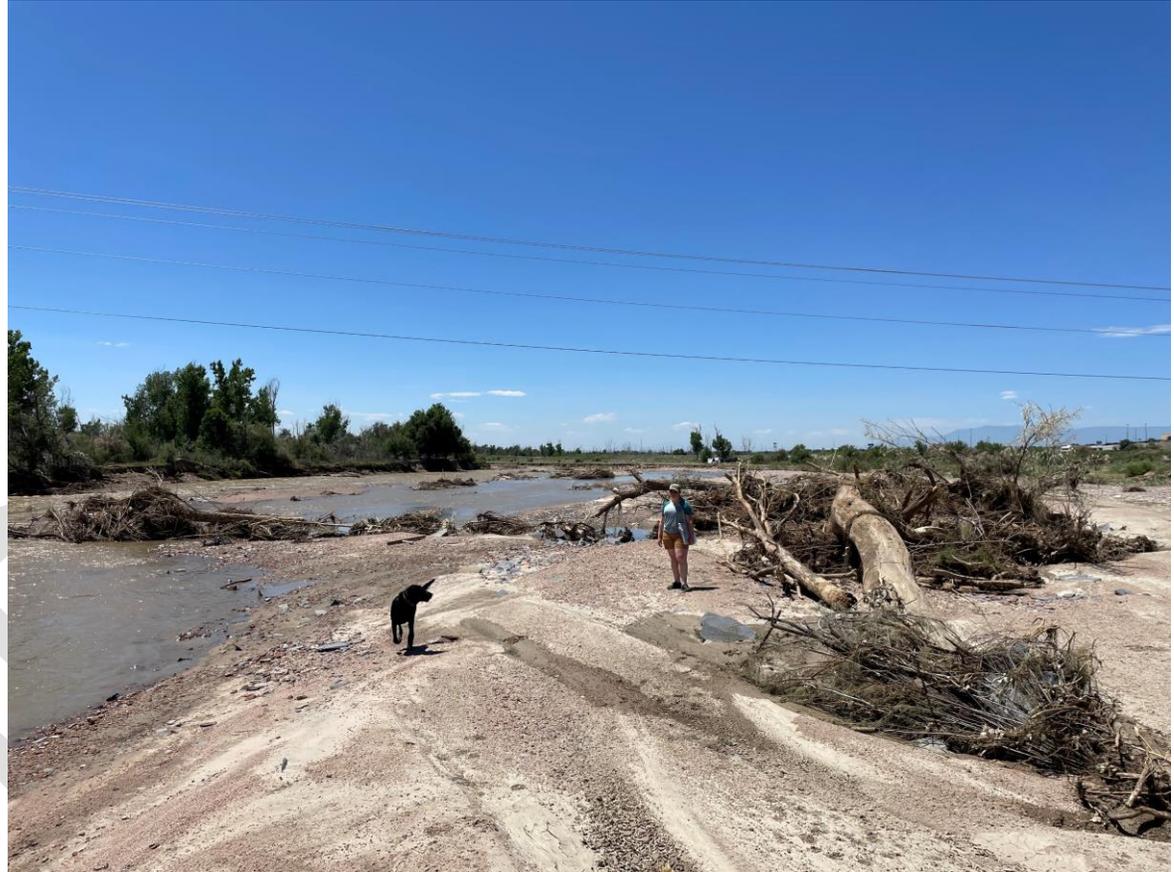
Waterline Bollards Looking Downstream

Photo 1 shows the exposed bollards with debris stacked along the bollards to the left. To the right, large woody debris and associated sediment settlement have deposited, encouraging flows to the left side of the photo. This flow is outside the Project flow path.

The exposed bollards immediately adjacent to the upstream end of the Project were observed to be catching debris and acting as a baffle causing disruptions to flow as it entered the upstream end of the Project. At the low flow conditions of the site visit the bollards caused flow to spread as it entered the upstream end of the Project. In high flow conditions, it is believed that the bollards and associated debris acted as a significant flow impediment.

1. Remove upstream waterline bollards
2. Reestablish design grades across the site where degradation or deposition has occurred
3. Replace the riprap bank protection that was flanked in the upper bend (Bend 3)
4. Replace the riprap bank protection that was breached in the middle bend (Bend 2)
5. Revegetate areas where regrading is needed.

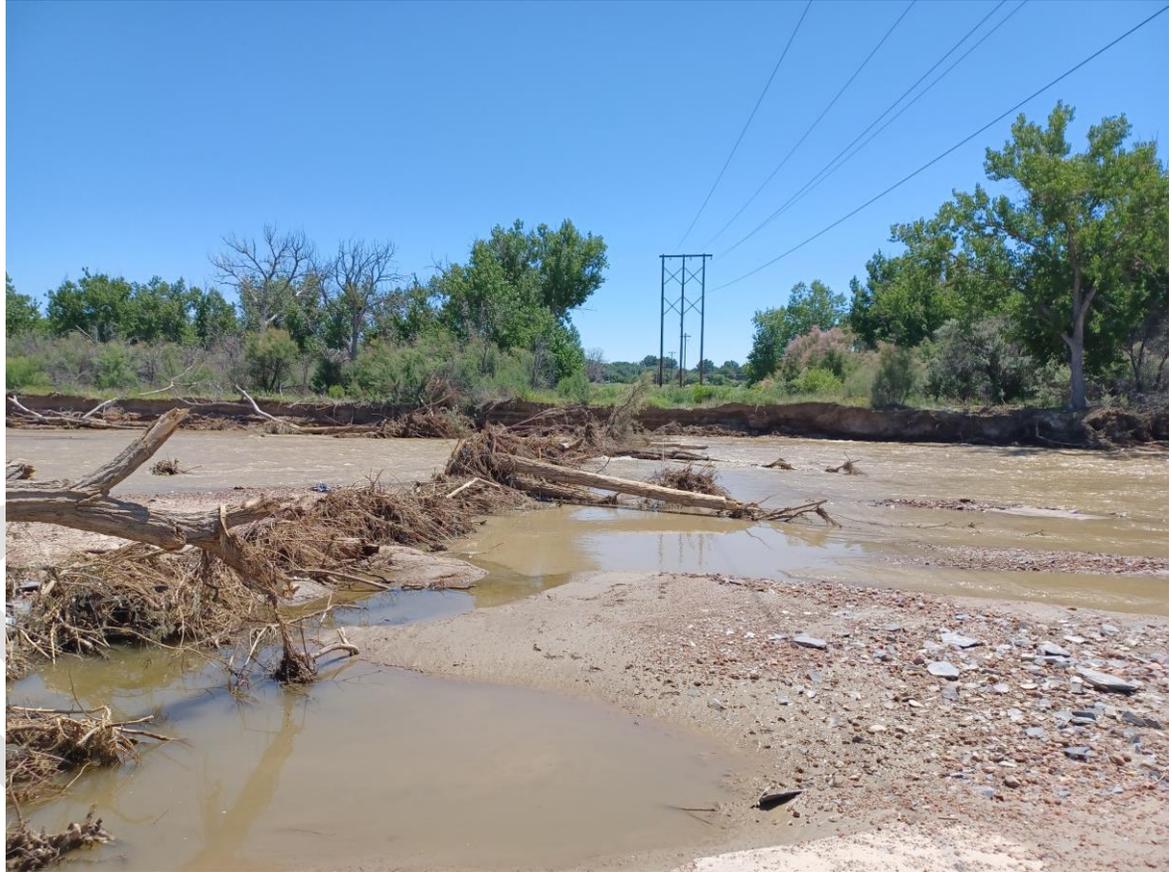
Photo 2

Waterline Bollards Looking East

Debris was observed to be piled along the bollards causing obstruction to the channel flow. The eroding bank where high flows flanked the bollards is visible in the background of the photo. The main channel has been pushed to the east of its previous position.

At low flow, a deep pool was observed on the upstream side of the bollards and the main flow path followed the exposed cut bank in the center of this photo.

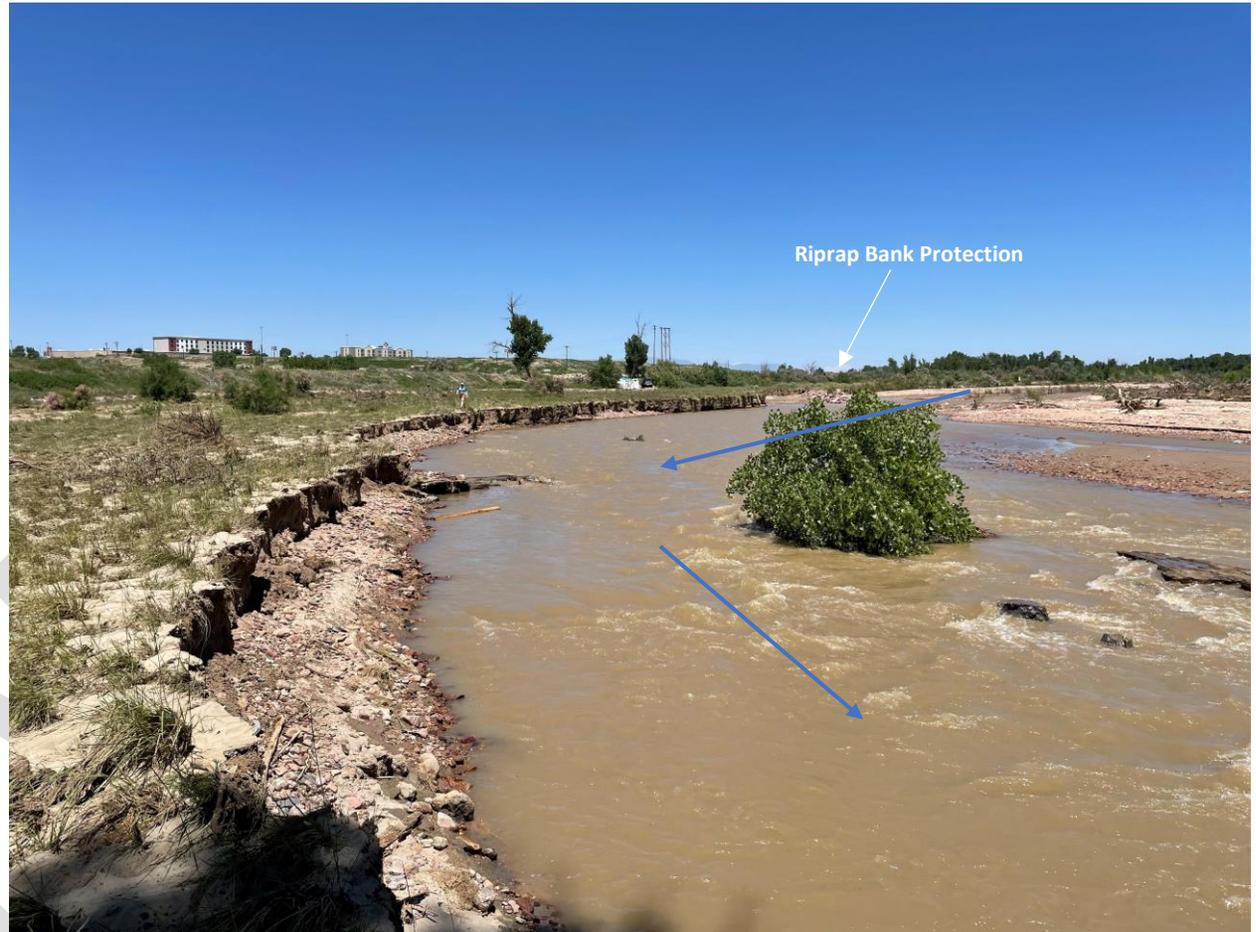
Upstream Bend Looking Upstream

Photo 3 shows erosion and lateral migration of the upstream meander bend. Note the riprap bank protection at the upstream end of the Bend 3.

Downstream of the bollards, flow has been redirected from its designed path and is approaching the upstream bend, nearly perpendicular to the channel. Annotative arrows have been added to Photo 3 to show the flow path observed during the site visit. This path caused excessive stress, likely beyond the design parameters, to be placed on the riprap bank protection. Riprap has been displaced in this bend and material has eroded behind much of the bank protection, resulting in a lateral migration of the bend downstream of the design location.

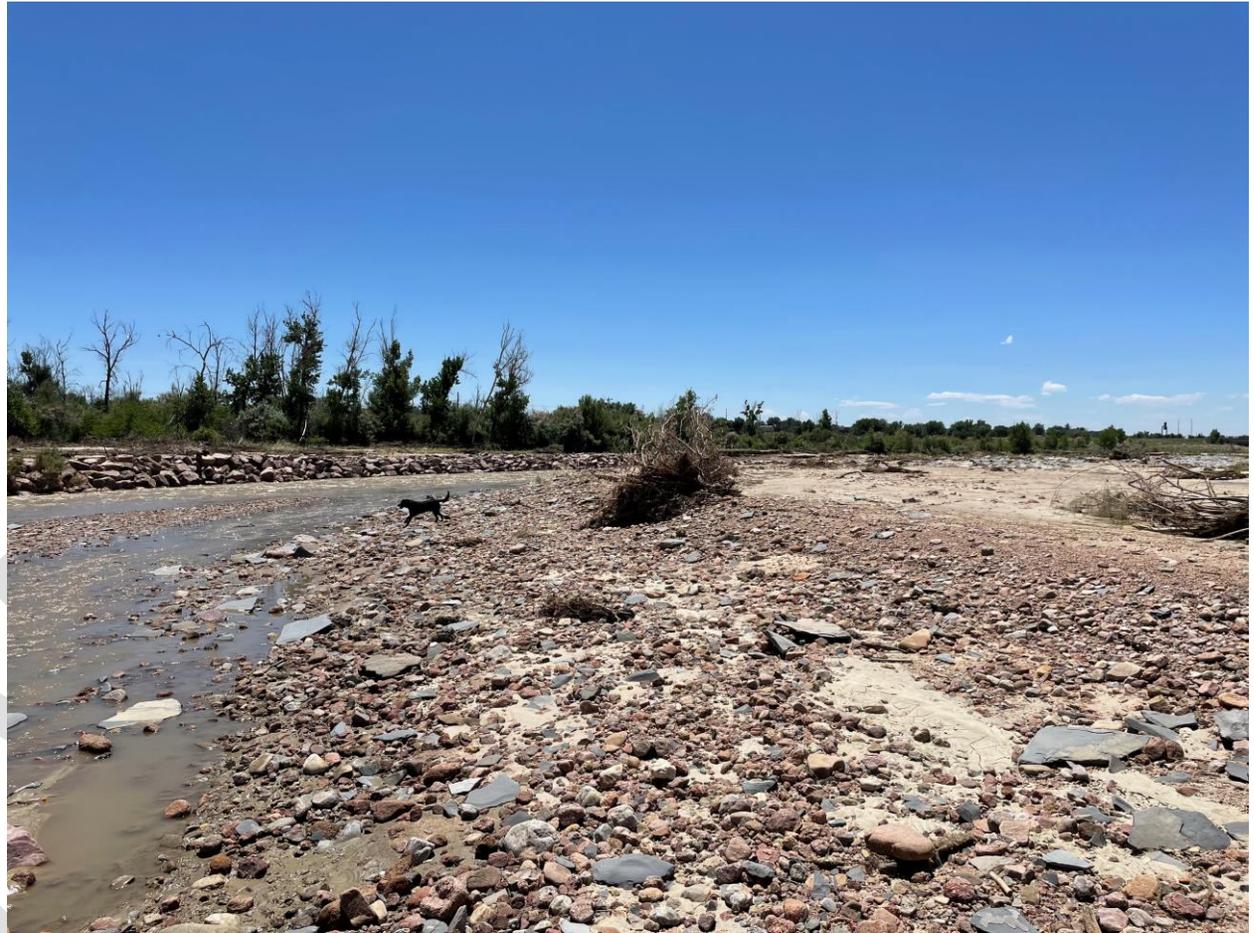
Photo 4

Middle Bend Looking Downstream

Excessive sediment deposition was observed on the inside of Bend 2. Matrix estimated the height of the point bar to be similar to the height of the top of the riprap bend protection located on the outside of the bend. This sediment was generally coarse gravel to cobble sized material that may have come from the upstream eroded bank.

The height of the point bar along the middle bend caused the main channel to become entrenched through the bend, likely exacerbating erosional processes.

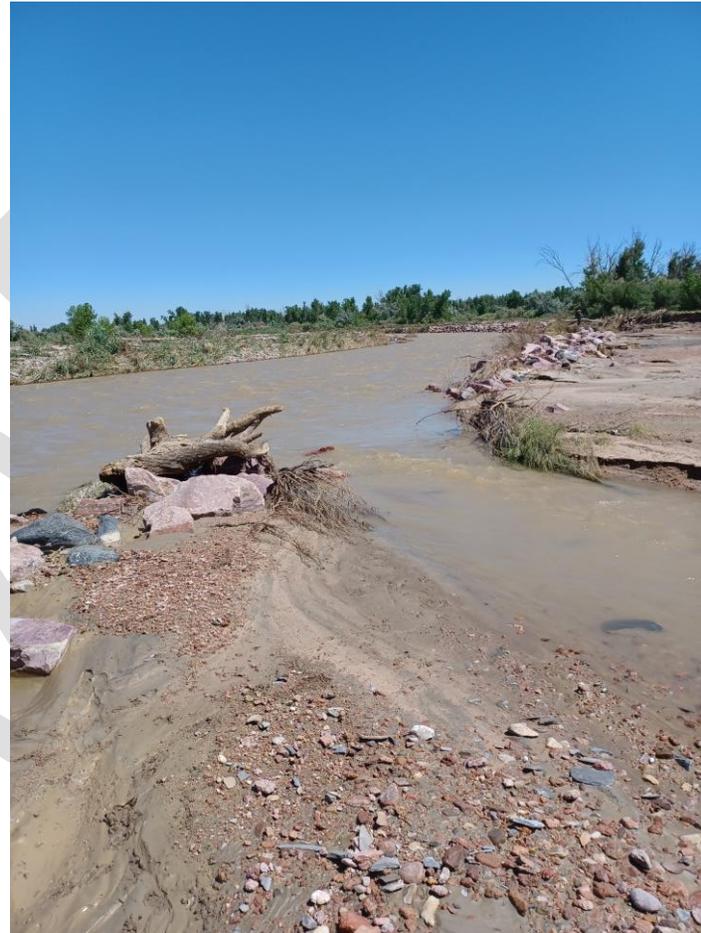
Photo 5

Middle Bend Looking Upstream

A breach in the riprap bend protection is located one-half to two-thirds of the way down the bend protection of Bend 2. In the top left of this photo, the elevation of the point bar can be seen. This breach may have been caused by the increased entrenchment causing increased forces to be exerted on the riprap bend protection.

The location of this breach is noted in the attached sketch map. Desktop analysis of flooding flow paths noted this breach is within a straight-line path downstream from the post-flooding bend.

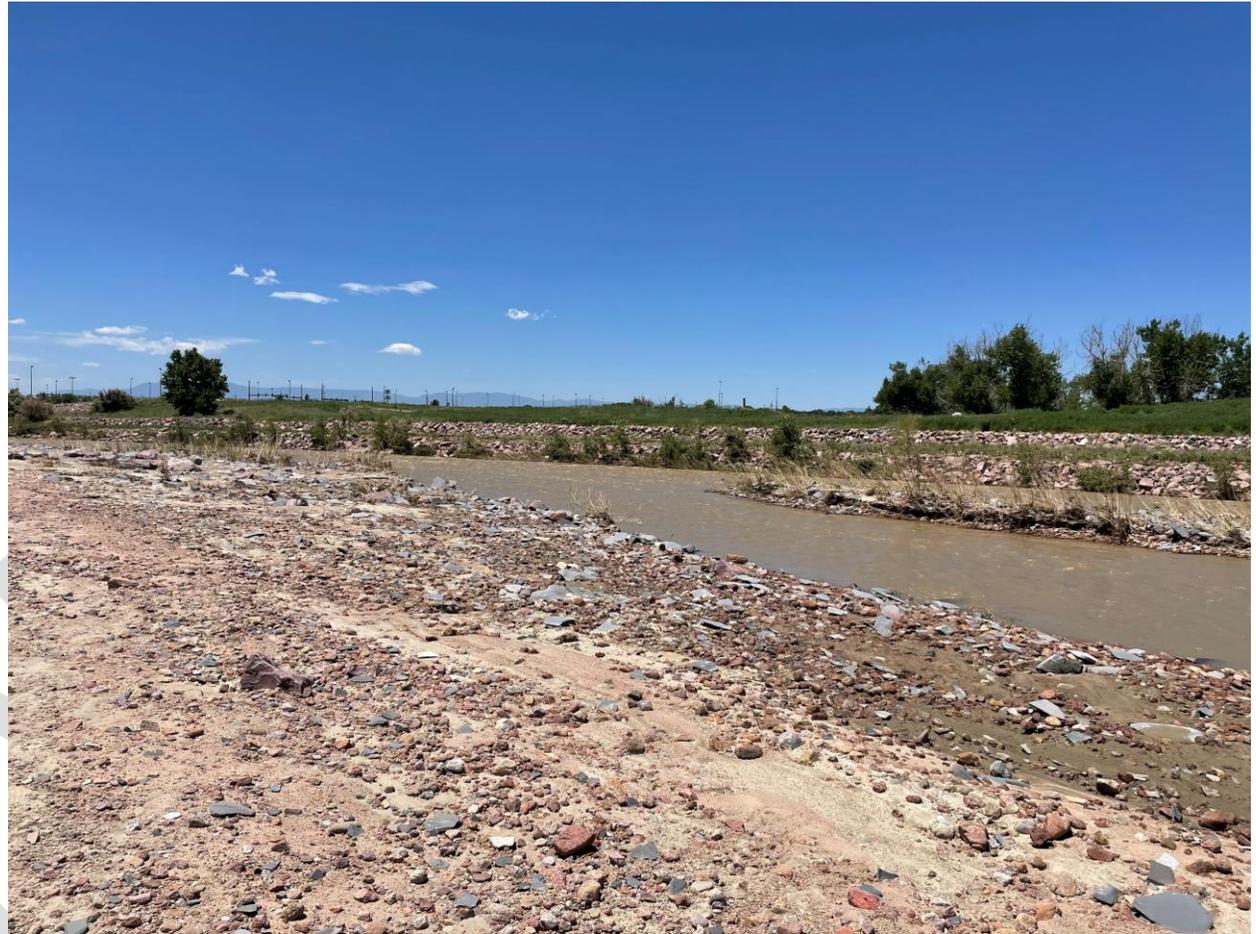
Photo 6

Downstream Bend Looking West

The downstream bend was observed to be functioning as intended, with some deposition observed on the inside of Bend 1. This deposition is likely a result of the upstream erosion described above. Riparian plantings were assessed and there was evidence that many had been buried under fine sediments on the floodplain.

Matrix did not observe any degradation of the riprap guide bank or immediate risks to the Highway 47 bridge due to the upstream site concerns.
