# FOUNTAIN CREEK WATERSHED STUDY

## WATERSHED MANAGEMENT PLAN

January 2009

**US Army Corps  
of Engineers** ®  
Albuquerque District

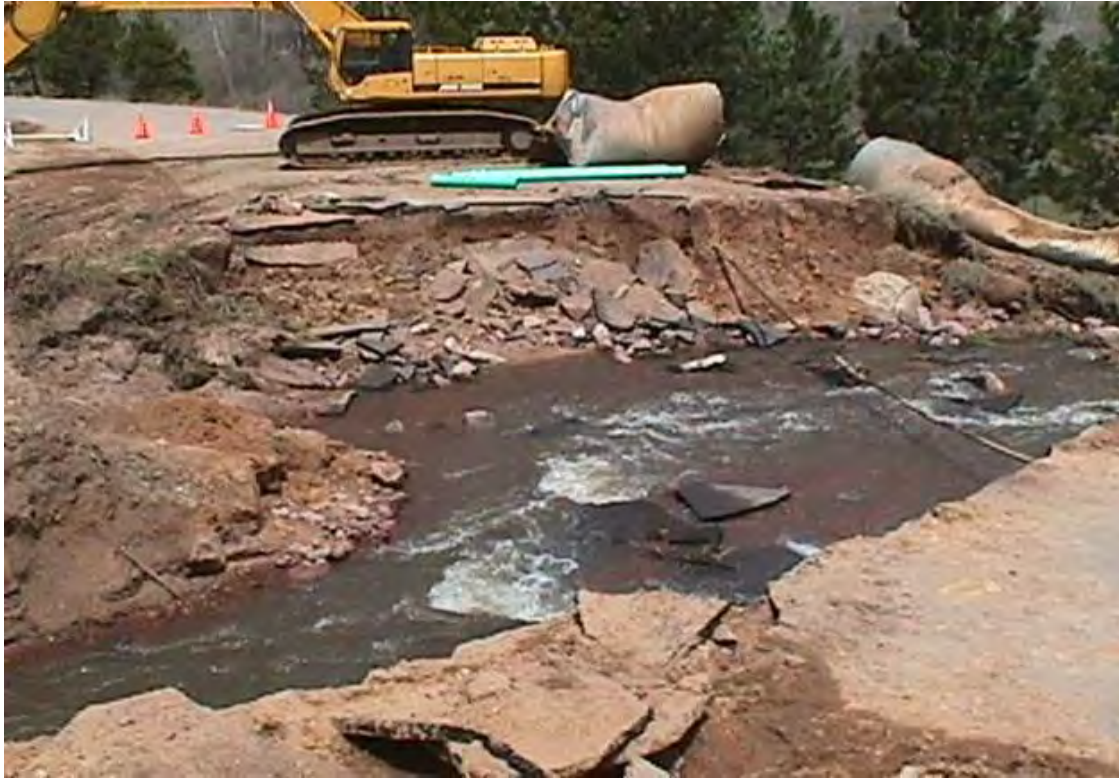
**Photo 1-1. Flood damage in Palmer Lake.**

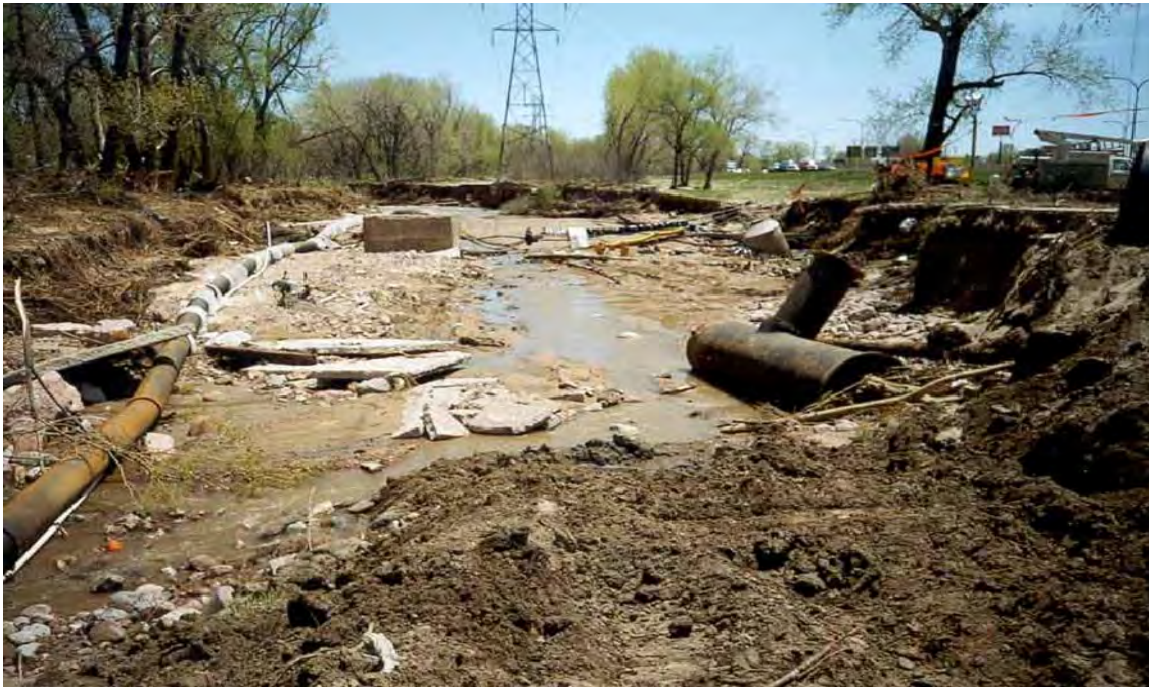
**Photo 1-3. Pipeline damage in Colorado Springs.**

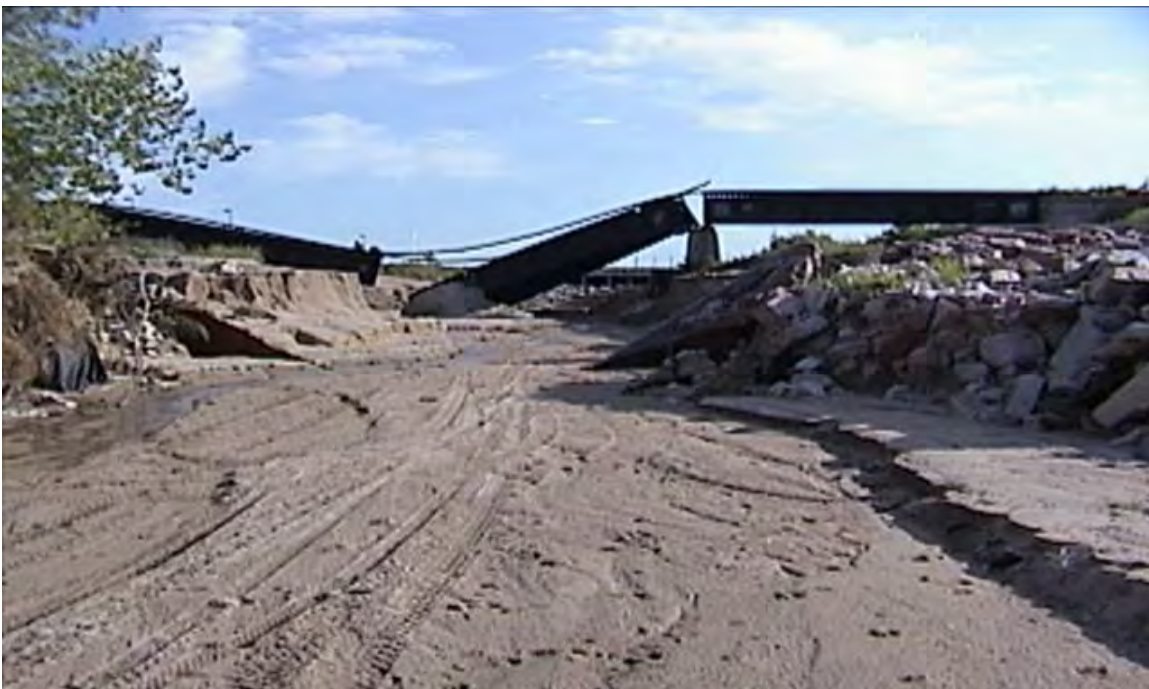
**Photo 1-4. Collapsed Railroad Bridge on Sand Creek.**

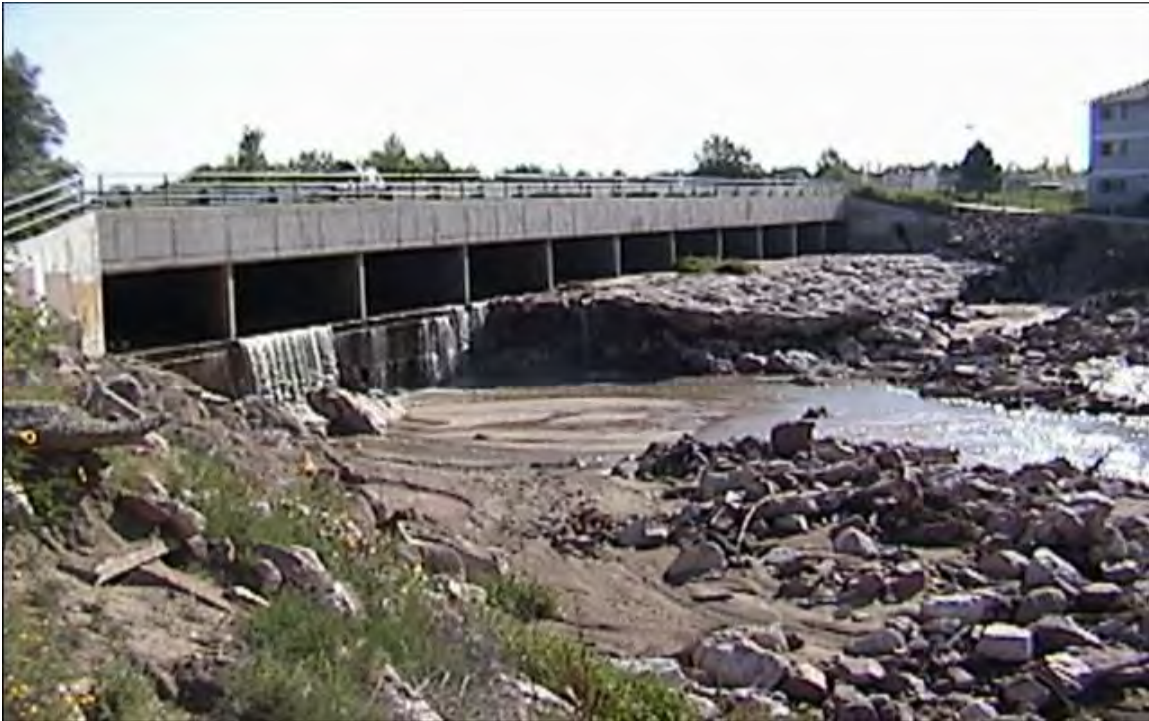
**Photo 1-7. Erosion on Sand Creek below Chelton Road in Colorado Springs.**

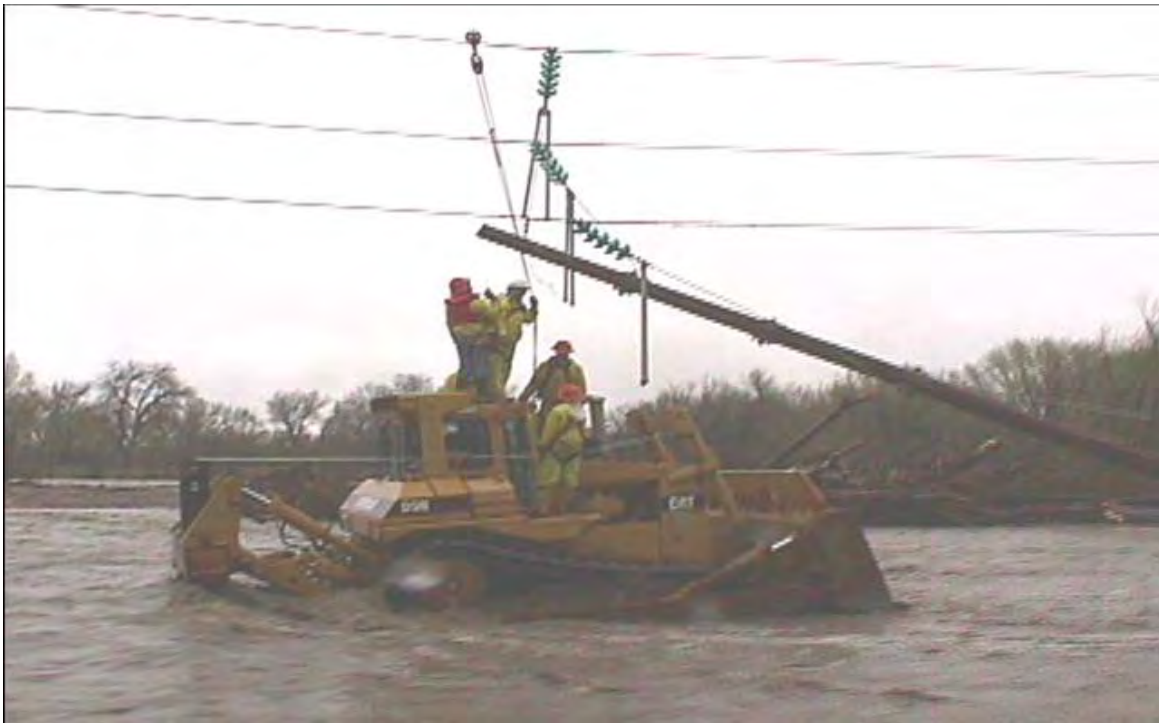
**Photo 1-9. Damage to electrical utilities in Fountain.**

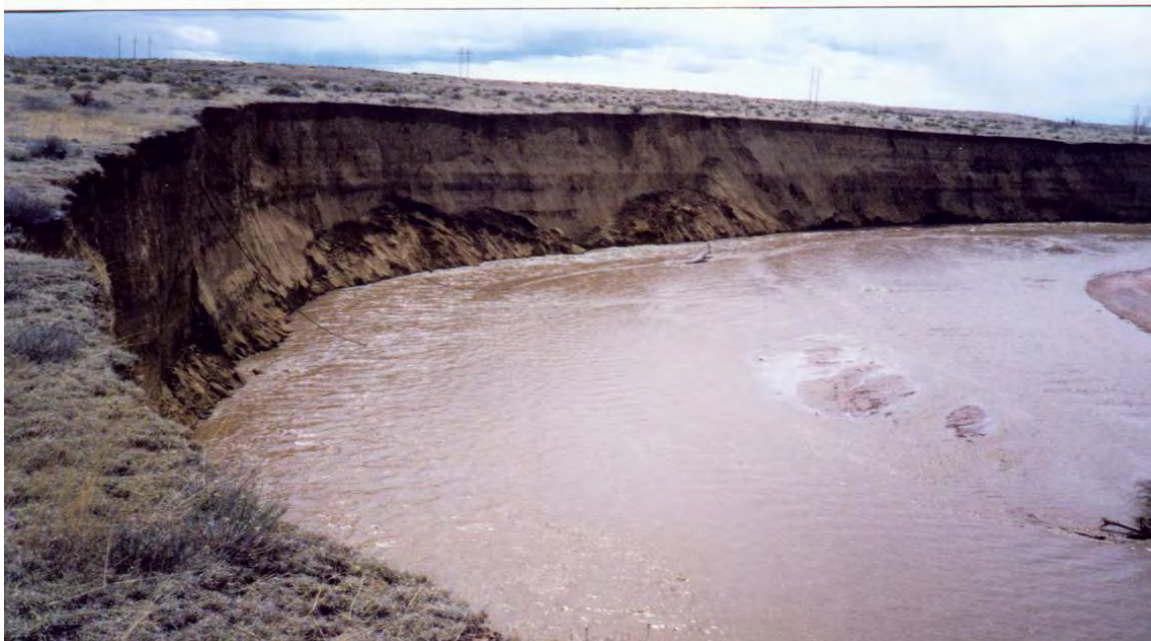
**Photo 1-10. Erosion in El Paso County.**

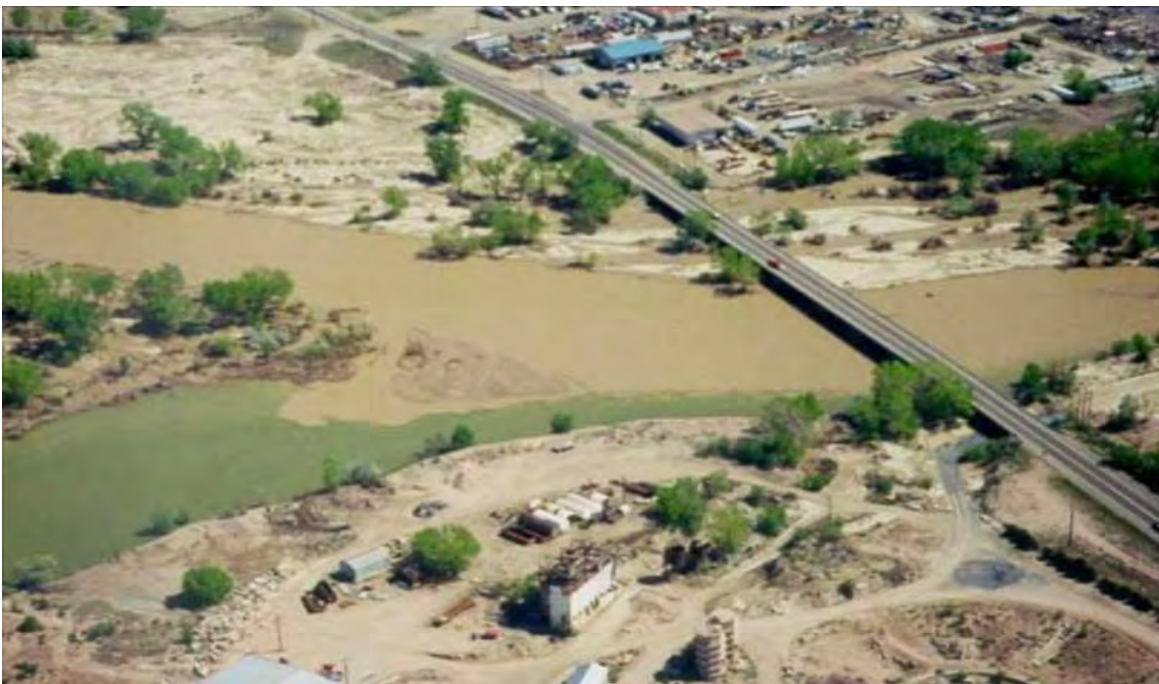
**Photo 1-14. Sedimentation at the Arkansas River confluence in Pueblo.**

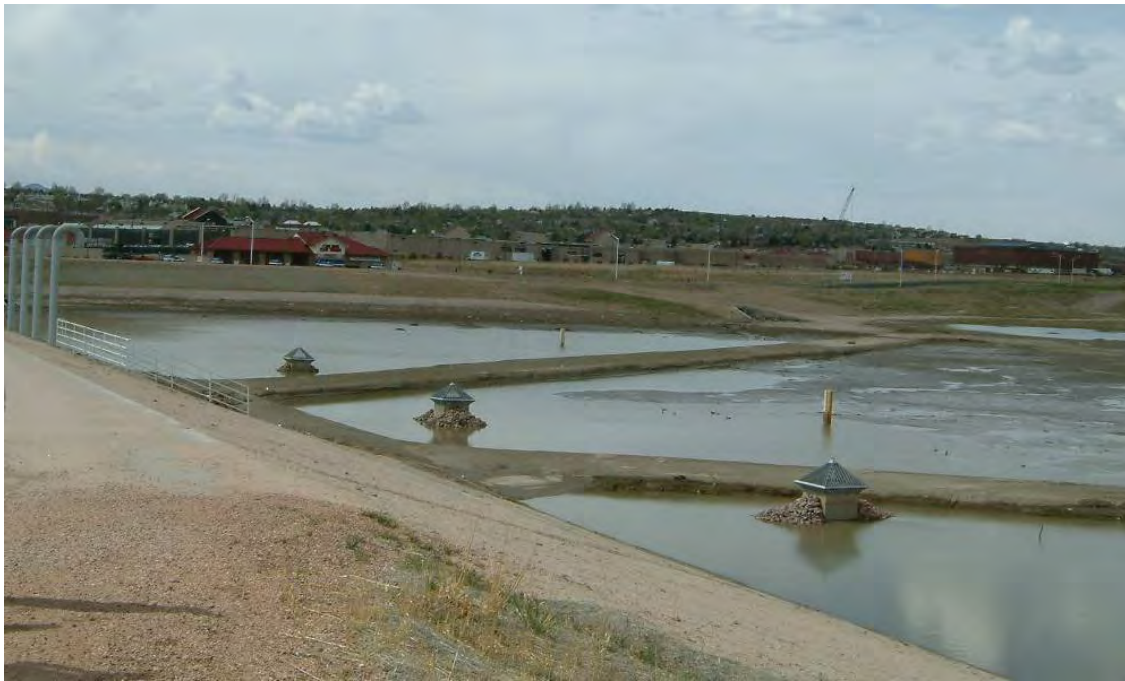
**Photo 1-15. Sand Creek Detention Pond 1.**

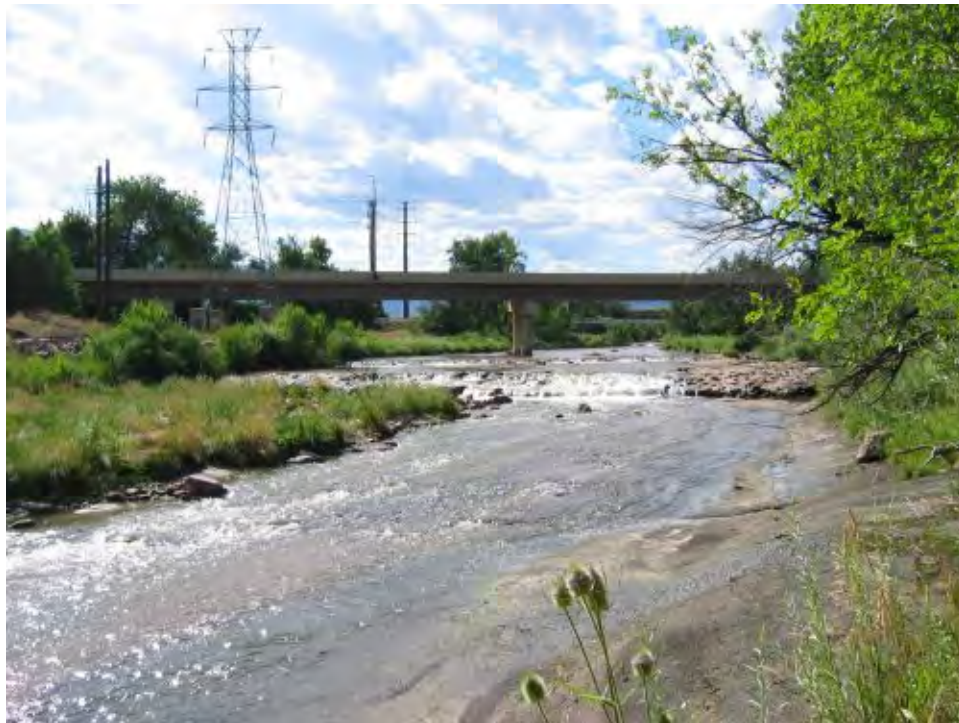
**Photo 2-1. Fountain Creek below Martin Luther King Bypass/Hwy 24**  
*Upstream view of double rock drop below on-ramp (0213)*

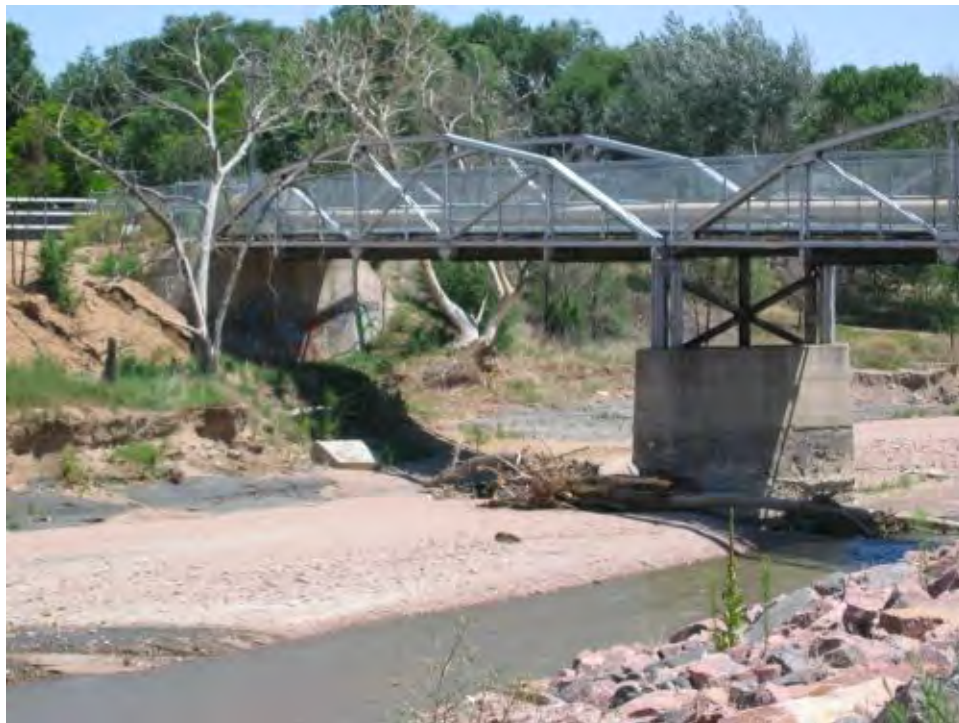
**Photo 2-3. Fountain Creek at USGS Security Gauge**  
*Downstream view of pipeline crossing showing evidence of degradation on bridge pier (0219)*

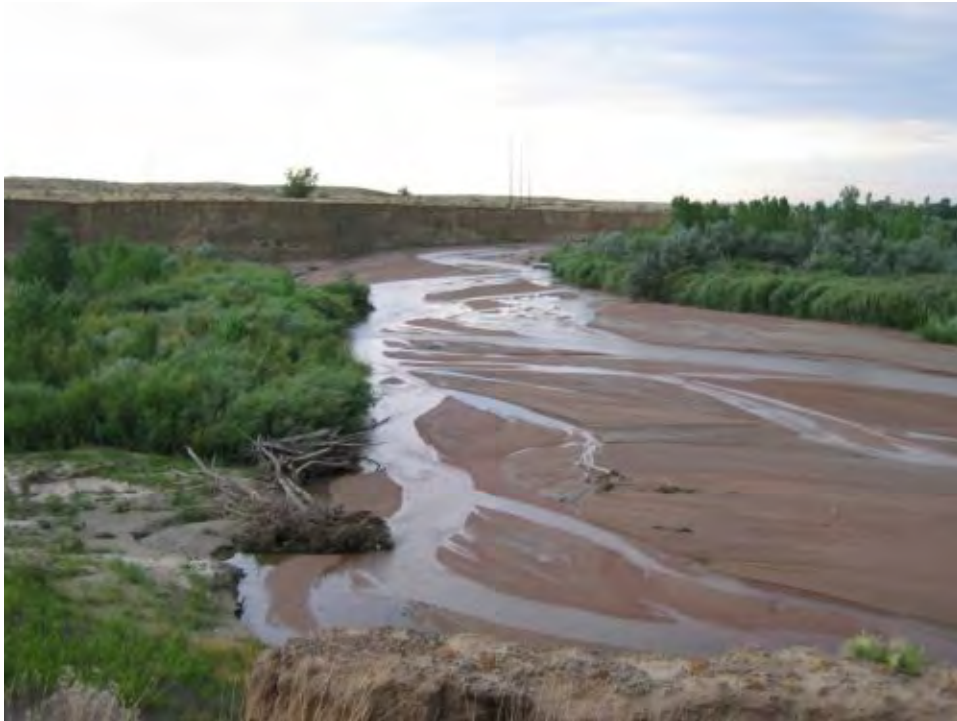
**Photo 2-4. Fountain Creek at Williams Creek confluence**  
*Downstream view on Frost property of aggrading channel reach with large cut bank (0381)*

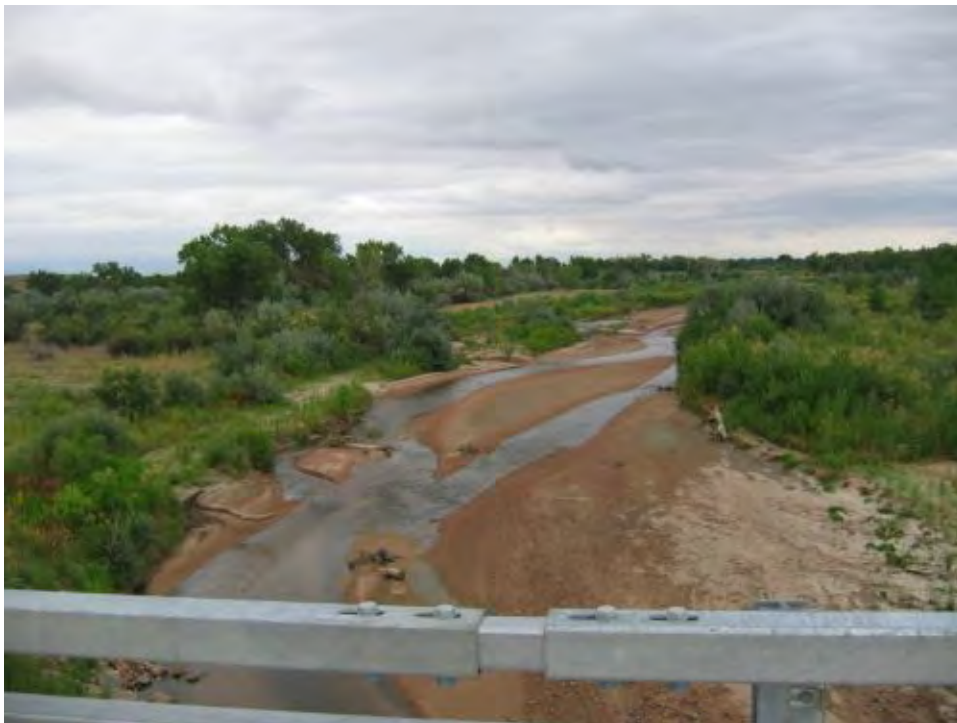
**Photo 2-5. Fountain Creek at new Pinon Road Bridge**  
*Upstream view of typical channel reach with braided low flow (0367)*

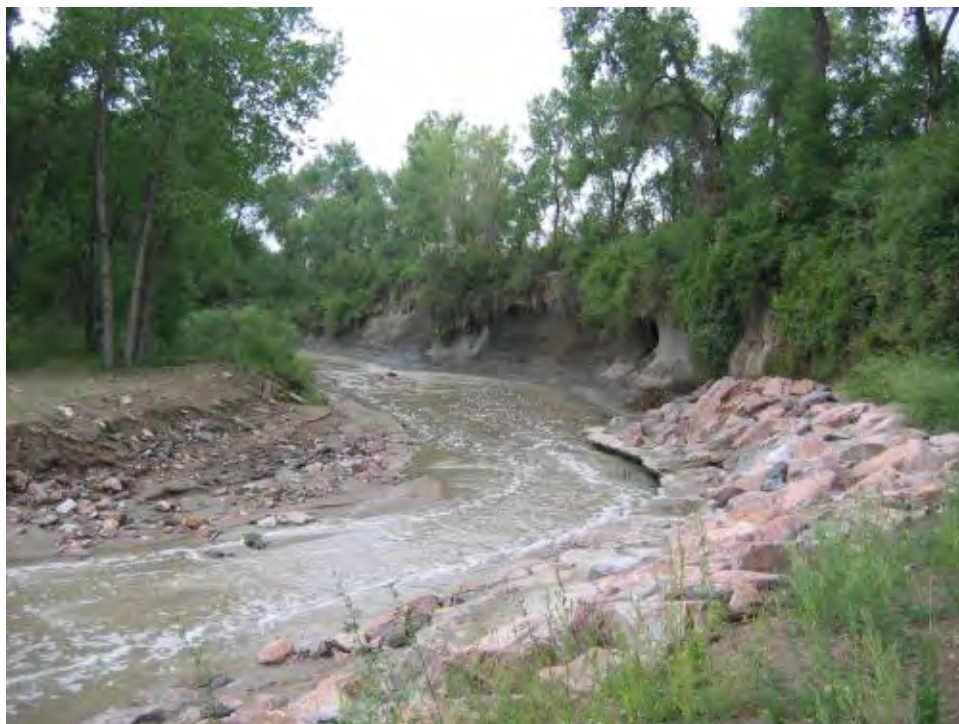
**Photo 2-9. Monument Creek near Templeton Gap Floodway confluence**  
*Downstream view of showing channel degradation and riprap on eroding right bank (0133)*

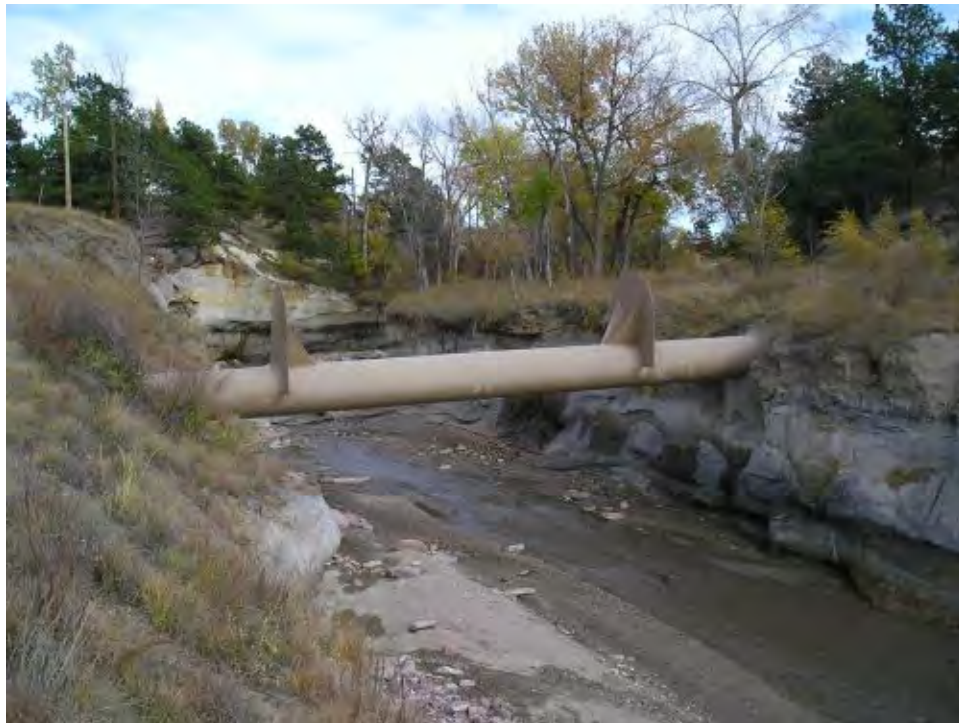
**Photo 2-12. Cottonwood Creek near Wicklow Circle**  
*Upstream view of a suspended utility and severe channel degradation (0693)*

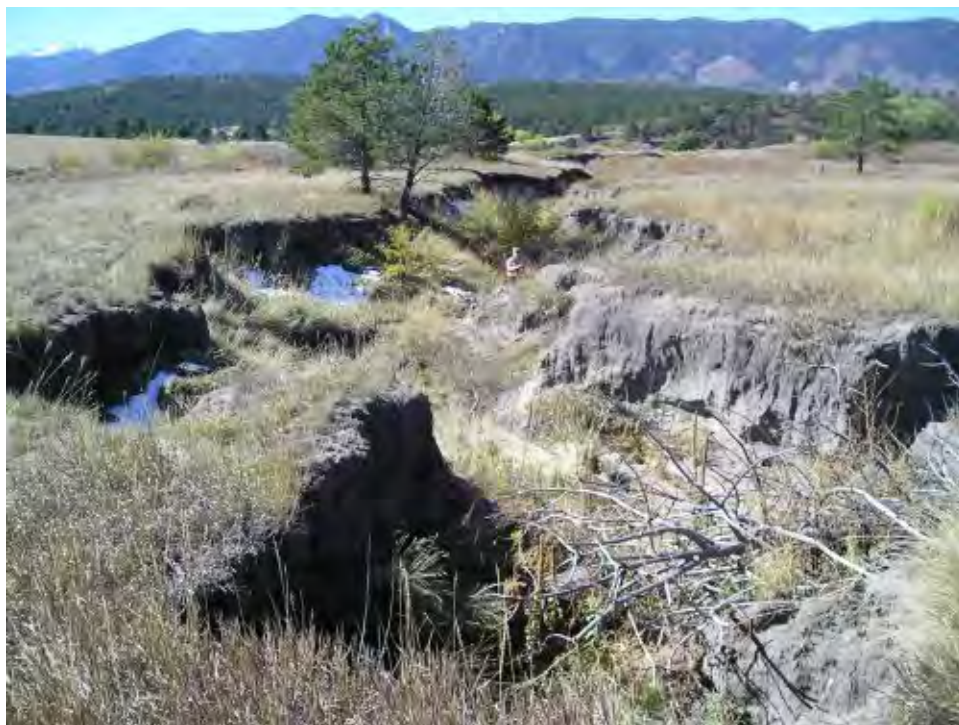
**Photo 2-13. Black Forest Creek west of I-25**  
*Downstream view of unstable gully channel (0588)*

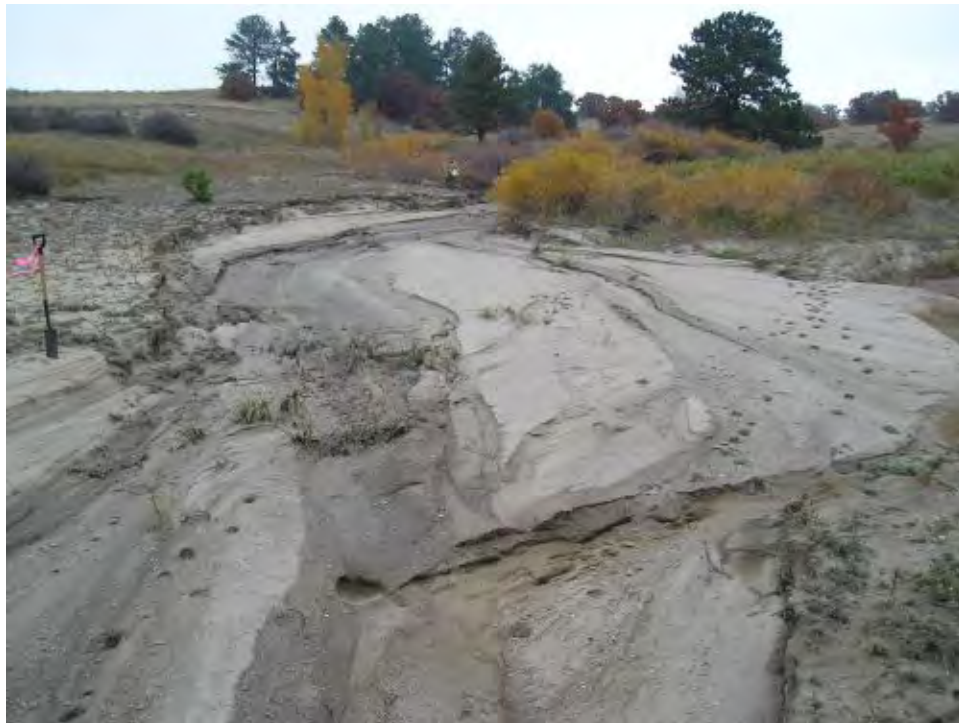
**Photo 2-14. Monument Branch below Voyager Parkway**  
*Upstream view at the confluence of the north and south tributaries of unstable degraded reach (0638)*

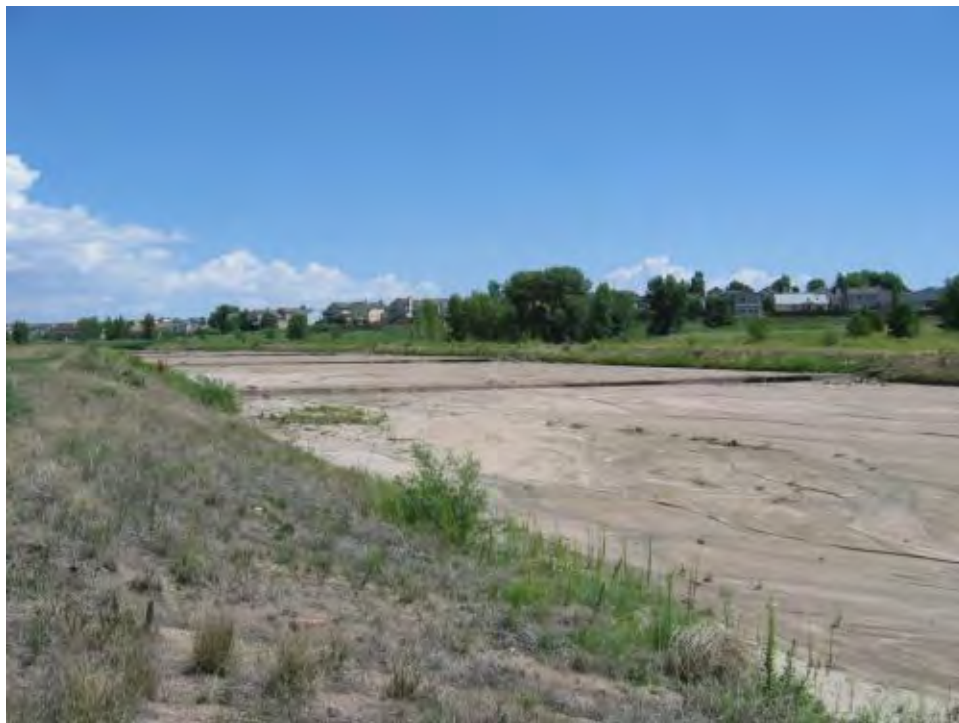
**Photo 2-15. Sand Creek upstream of Constitution Avenue**  
*Upstream view of severely aggraded, channelized reach with drop structures (0281)*

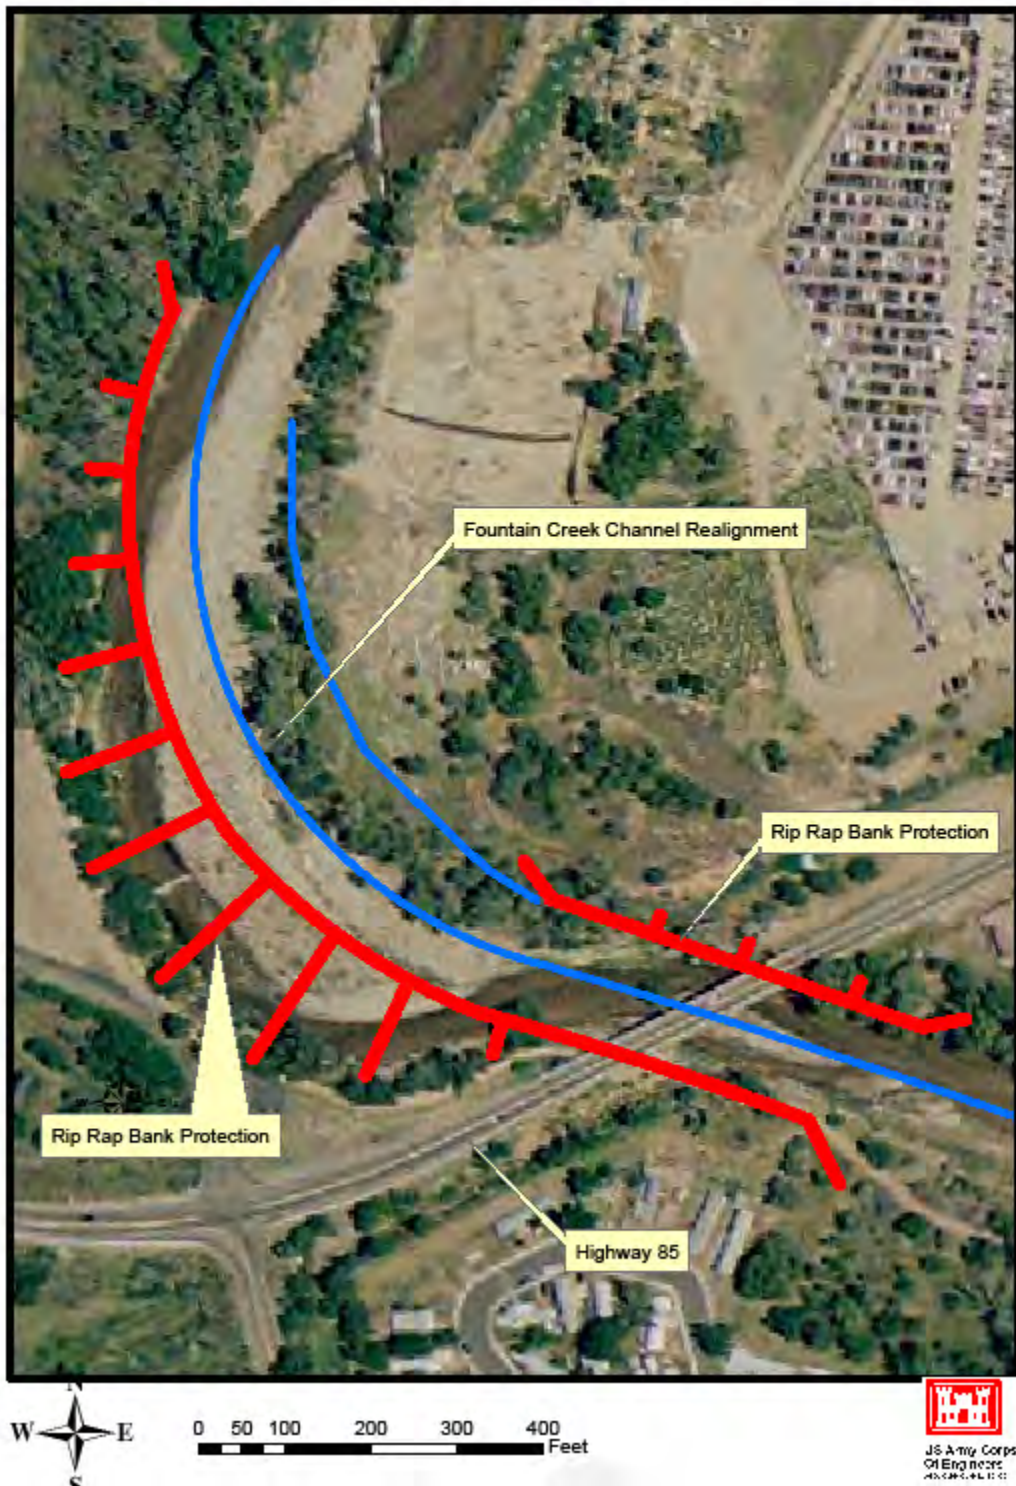
Figure 4-9. Highway 85 Bridge.
